Dynamic characteristics of the *Amphitheatrum Flavium* northern wall from traffic-induced vibrations

Giovanni Bongiovanni¹, Giacomo Buffarini¹, Paolo Clemente^{1,*}, Dario Rinaldis¹, Fernando Saitta¹

¹ ENEA Casaccia Research Centre, Rome, Italy

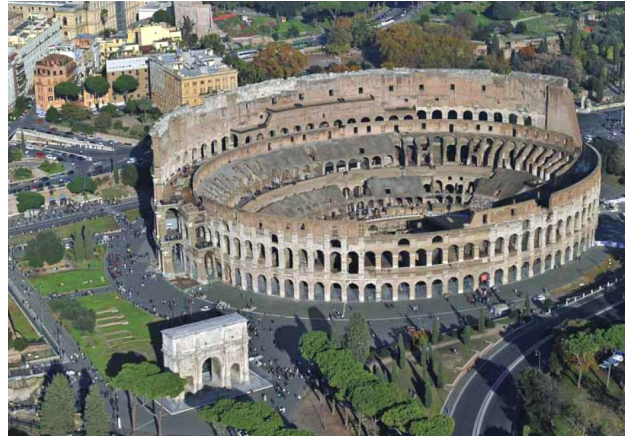
The *Amphitheatrum Flavium*, better known in the world as Colosseum, is the largest amphitheater ever built. Its construction began under the emperor Vespasian in 72 A.D., and was completed under emperor Titus in 80 A.D.. It is an entirely free-standing structure, elliptical in plan, 189 m long and 156 m wide (Figure 1).

Figure 1. View of the Amphitheatrum Flavium with the northern wall.

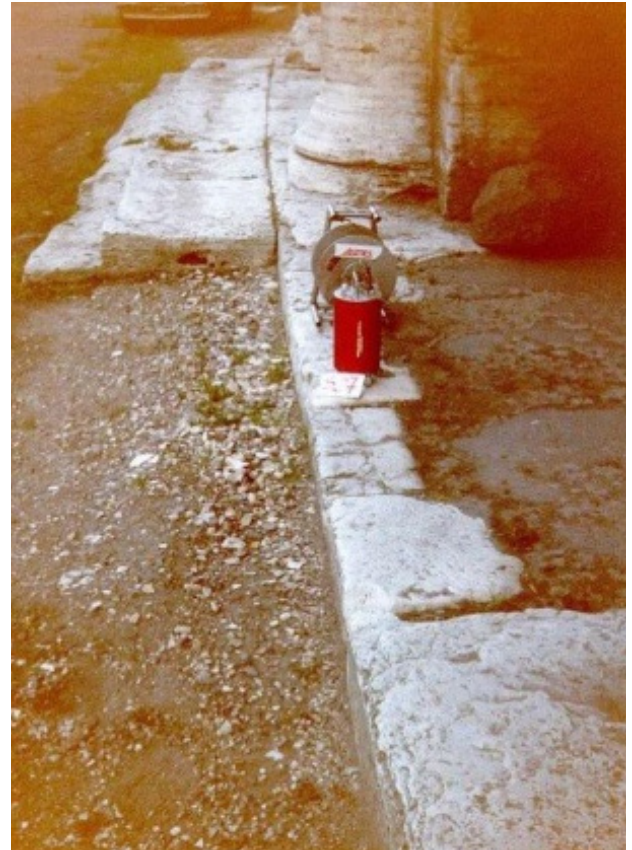
Figure 15. Vertical seismometer S27 in configuration C4.

In the first experimental campaign a fourth layout (C4) regarded the measurement of the vertical vibrations: four vertical seismometers were located

on the basement (locations S25 to S28, Figures 3,15). In the recordings obtained at S25, which is very close to the underground line, two passages of the trains are evident (Figure 16, in the intervals 10-30 and 100-120 s). Their effects become negligible going to locations far from the underground as demonstrated by the corresponding RMSs (S26, S27 and S28) plotted in Figure 17. In absence of the train passage, velocity amplitudes were almost similar at all the locations. Furthermore, vertical values were much lower than the horizontal ones obtained on the basement in the other configurations.
